RESEARCH MEMORANDUM

FACILITIES AND METHODS USED IN FULL-SCALE
AIRPLANE CRASH-FIRE INVESTIGATION

By Dugald O. Black

Lewis Flight Propulsion Laboratory
Cleveland, Ohio

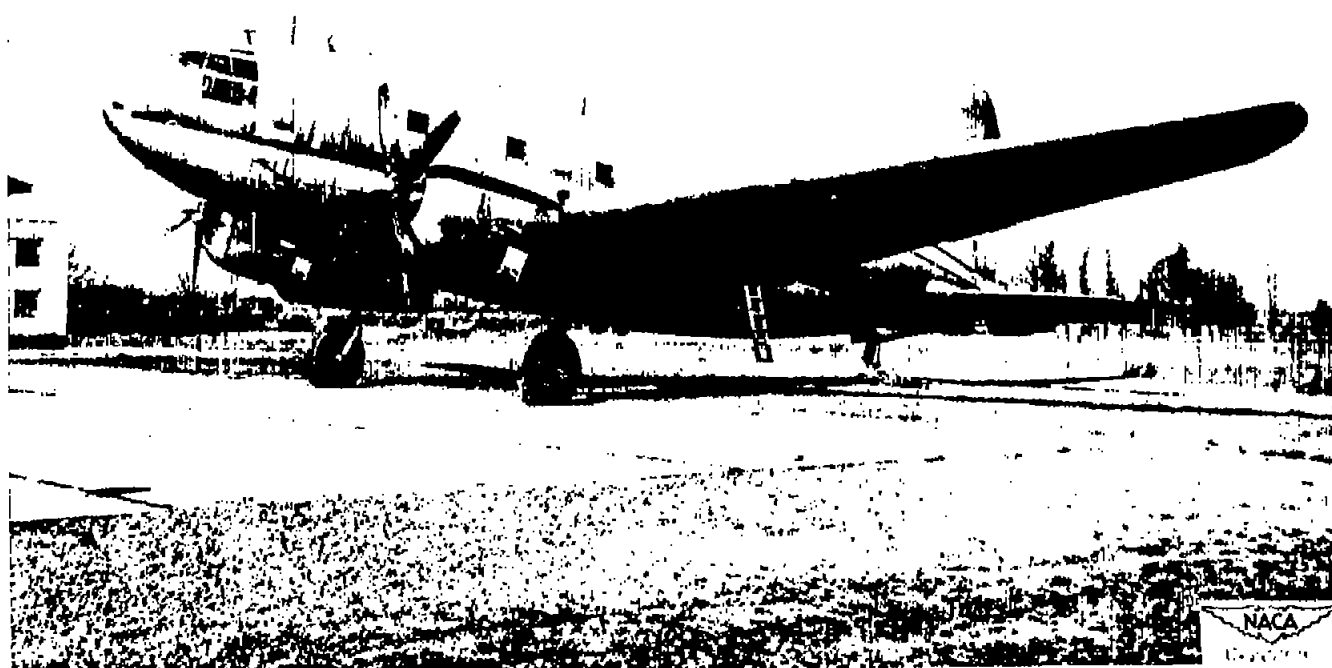
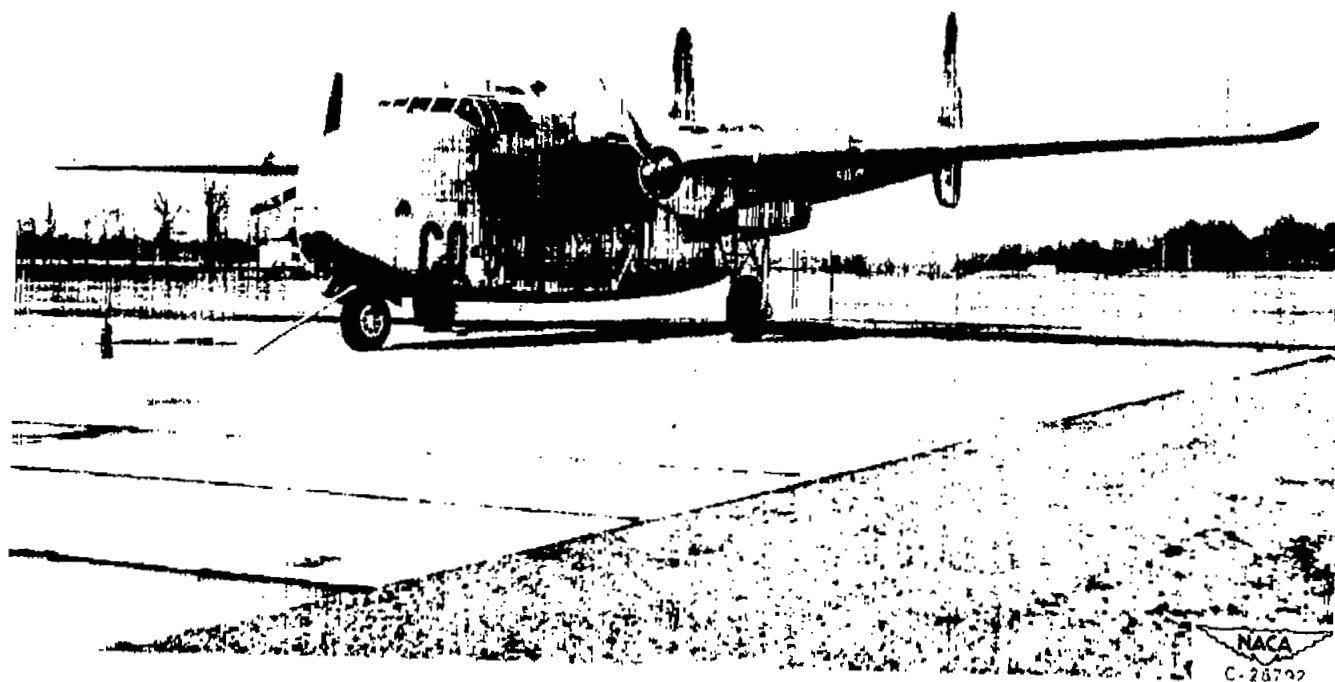
(a) C-46.

Figure 1. - Airplanes used in full-scale crash-fire investigation.

(b) C-82.

The NACA full-scale crash-fire investigation was conducted on C-46 and C-82 airplanes of the type shown in figure 1. The United States Air Force provided valuable assistance in conducting the investigation by supplying the war-weary and obsolete test airplanes.

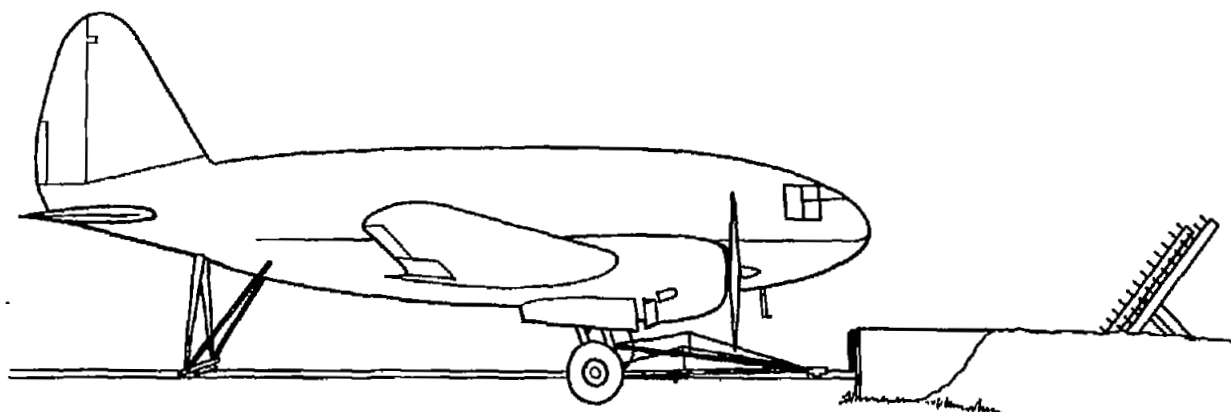
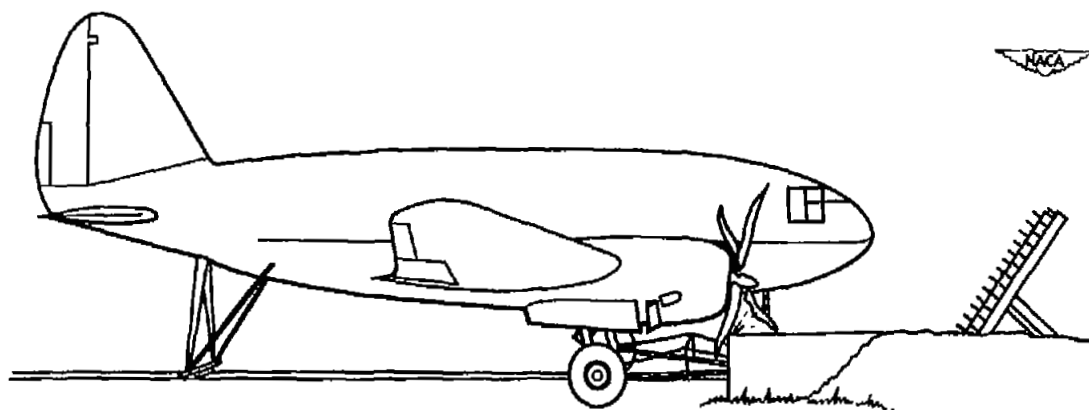
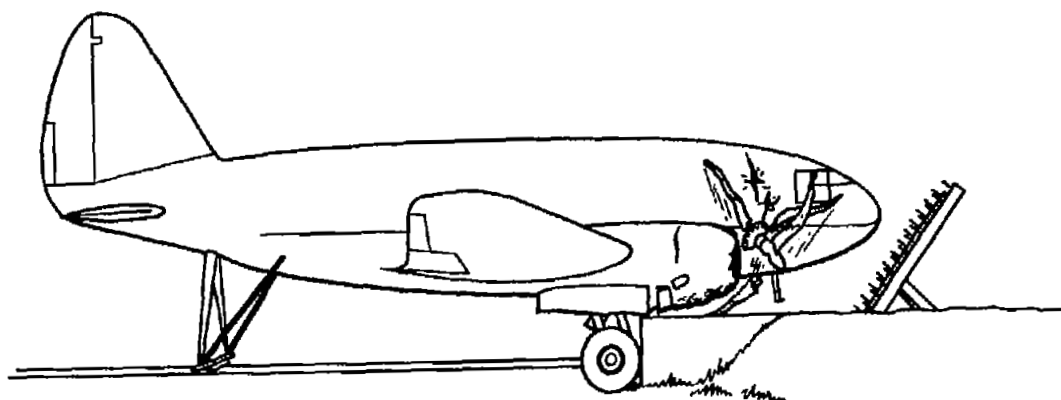
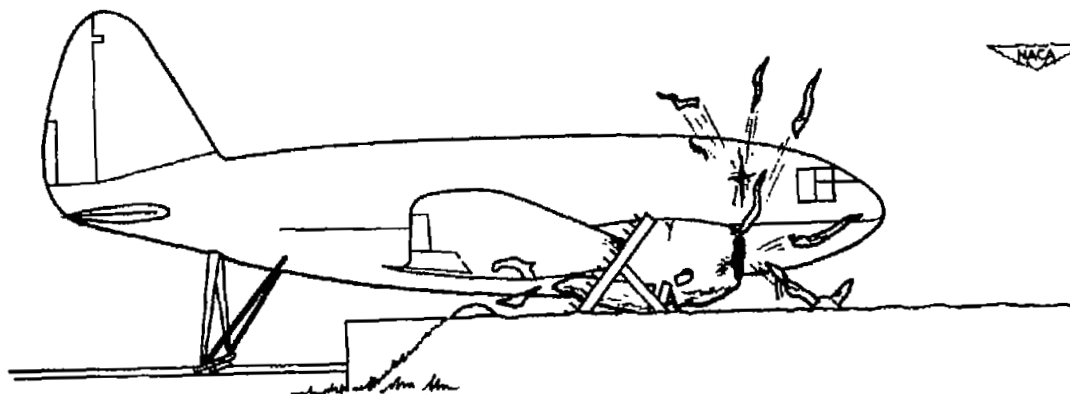
(a) Airplane approaching crash barrier.

Figure 2. - Schematic diagrams showing location of crash and pole barrier with respect to various components of C-46 airplane.

(b) Propeller strikes crash barrier.

(c) Main landing gear strikes crash barrier.

(d) Wings about to strike pole barrier.

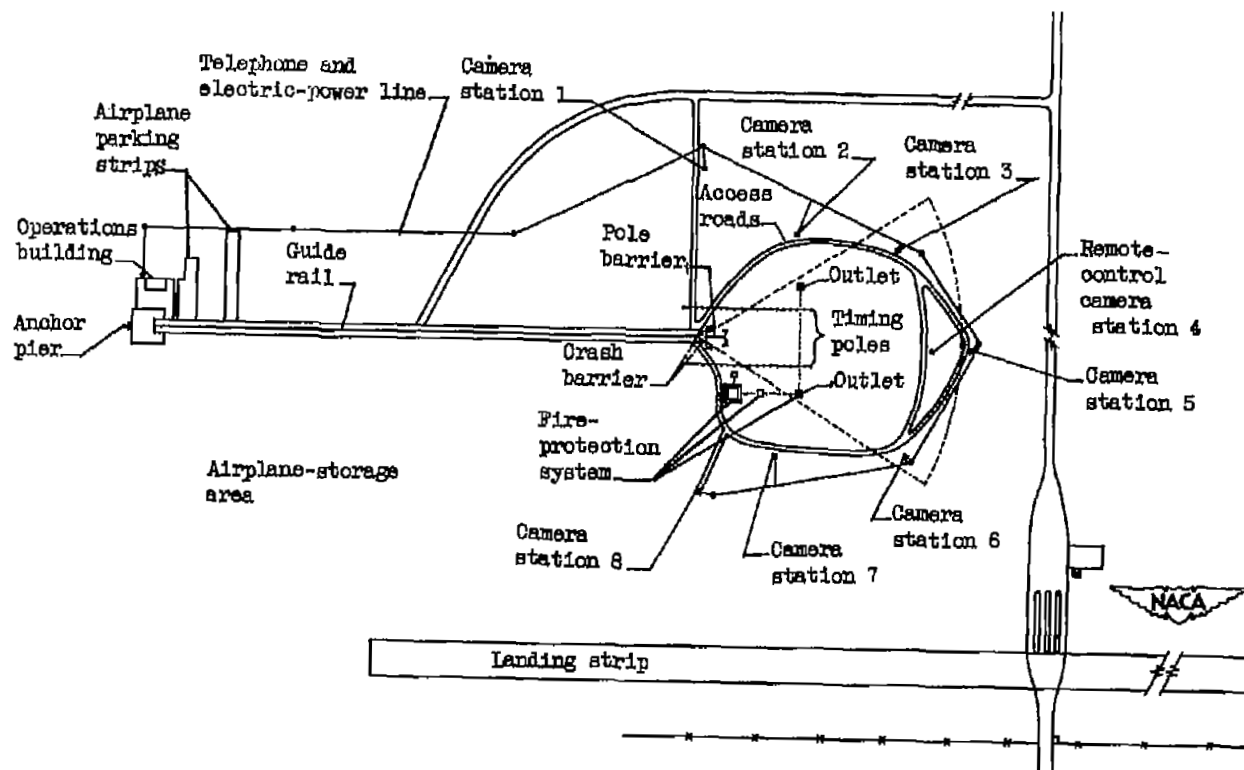
Figure 3. - Plan view of test site for conducting full-scale crash-fire investigation.

Camera platforms, from which motion pictures of the crash were recorded, were located at seven places around the crash area (fig. 3). Each platform was constructed of steel framework and armour plate for protection against flying debris (fig. 18). The height above the ground varied with each platform according to the requirements imposed by the terrain of the crash area.

Mitchell, Ciné, Fastax, and K-24 cameras, all operated electrically, were used in this investigation. Three Mitchell motion-picture cameras were located on the camera platforms at stations 2, 5, and 7 (see fig. 3). They operated without interruption throughout the crash and were loaded with a 1200-foot reel of 16 millimeter color film. These cameras operated at 128 frames per second as the airplane approached the crash barrier, through the subsequent crash, and slide to rest. The speed was then reduced to 48 frames per second for the remainder of the time. Only the Mitchell cameras were capable of taking motion pictures continuously throughout the crash and ensuing fire.

Two Ciné cameras were installed on camera platforms at stations 3 and 6 (see fig. 3). They were equipped with a 200-foot roll of 16 millimeter color film and operated at 24 frames per second. These two cameras were installed primarily as a precautionary measure in case of failure of the Mitchell cameras.

The Fastax high-speed motion-picture cameras were installed on the camera platforms at stations 1, 4, and 8 (see fig. 3). The camera installed at station 4 was remotely controlled by the operator in station 5. These cameras operated at speeds of from 100 to 1000 frames per second with either 16 millimeter black and white or high-speed color film. The speed and type of film used depended upon light conditions during the test. The film from Fastax cameras was studied to obtain information concerning the actual breakup of the airplane.

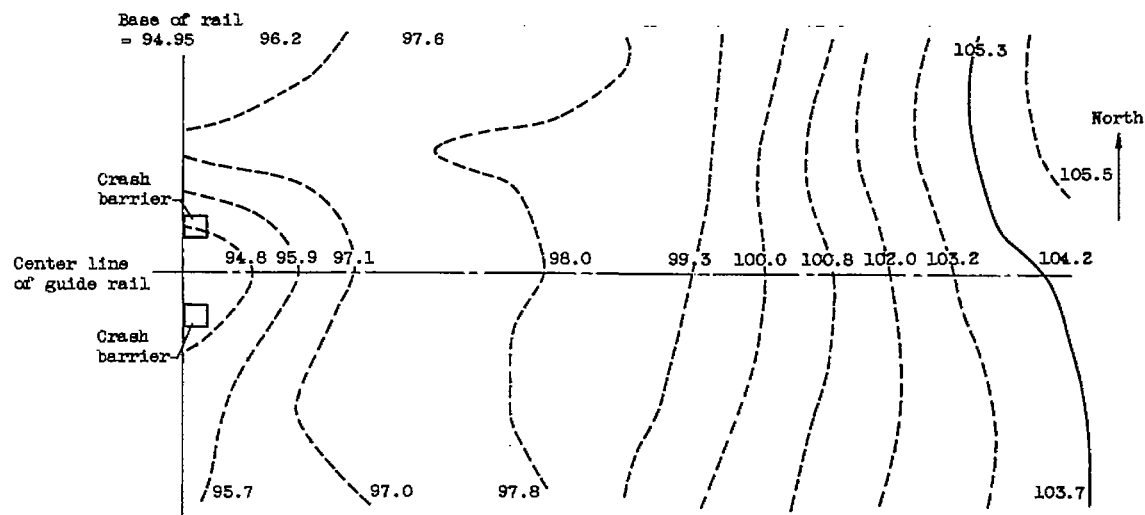
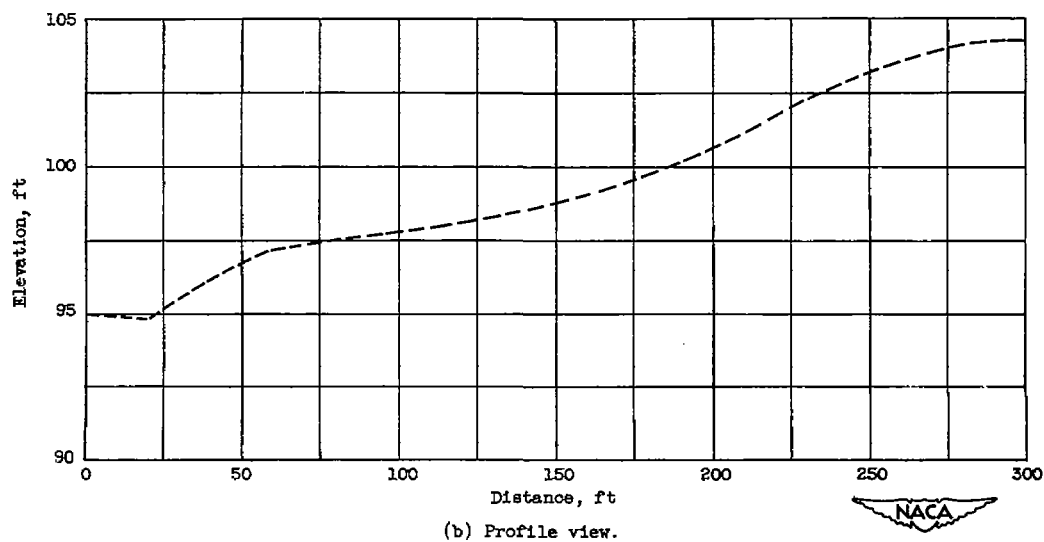
(a) Plan view.

(b) Profile view.

Figure 4. - Crash area in which the crash-fire investigation was conducted.

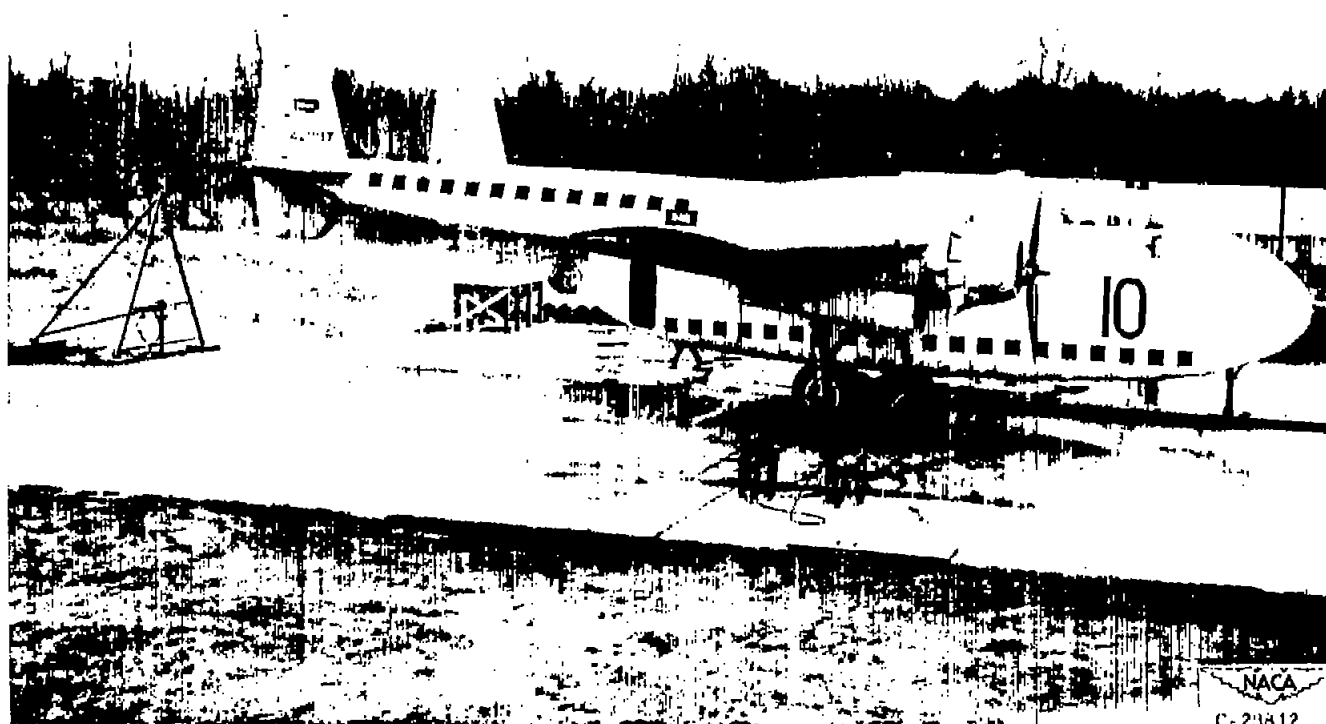
(a) Side view.

Figure 5. - C-82 Airplane being readied in preparation area for test.

(b) Front view.

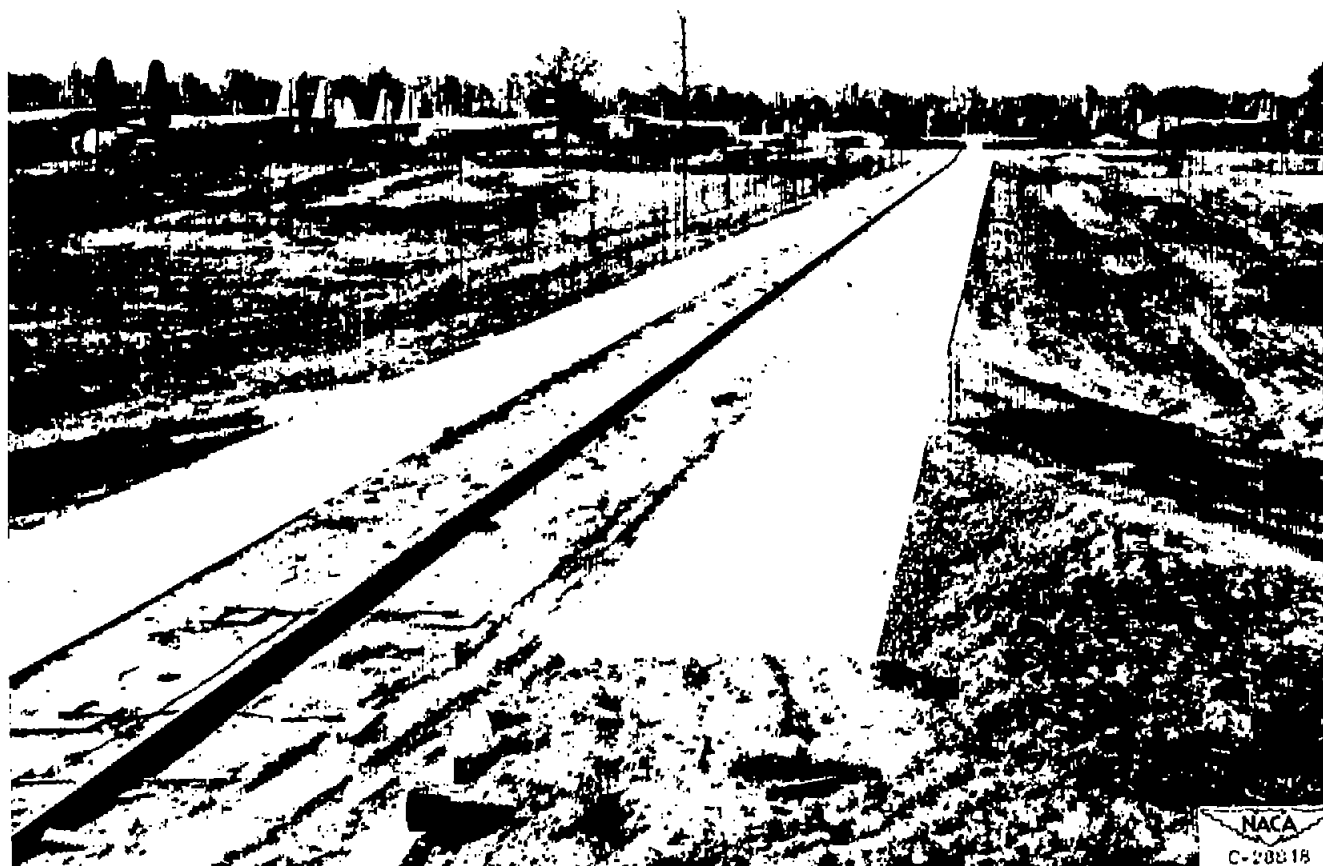
Figure 6. - Runway and center rail for guiding airplanes to crash barrier.

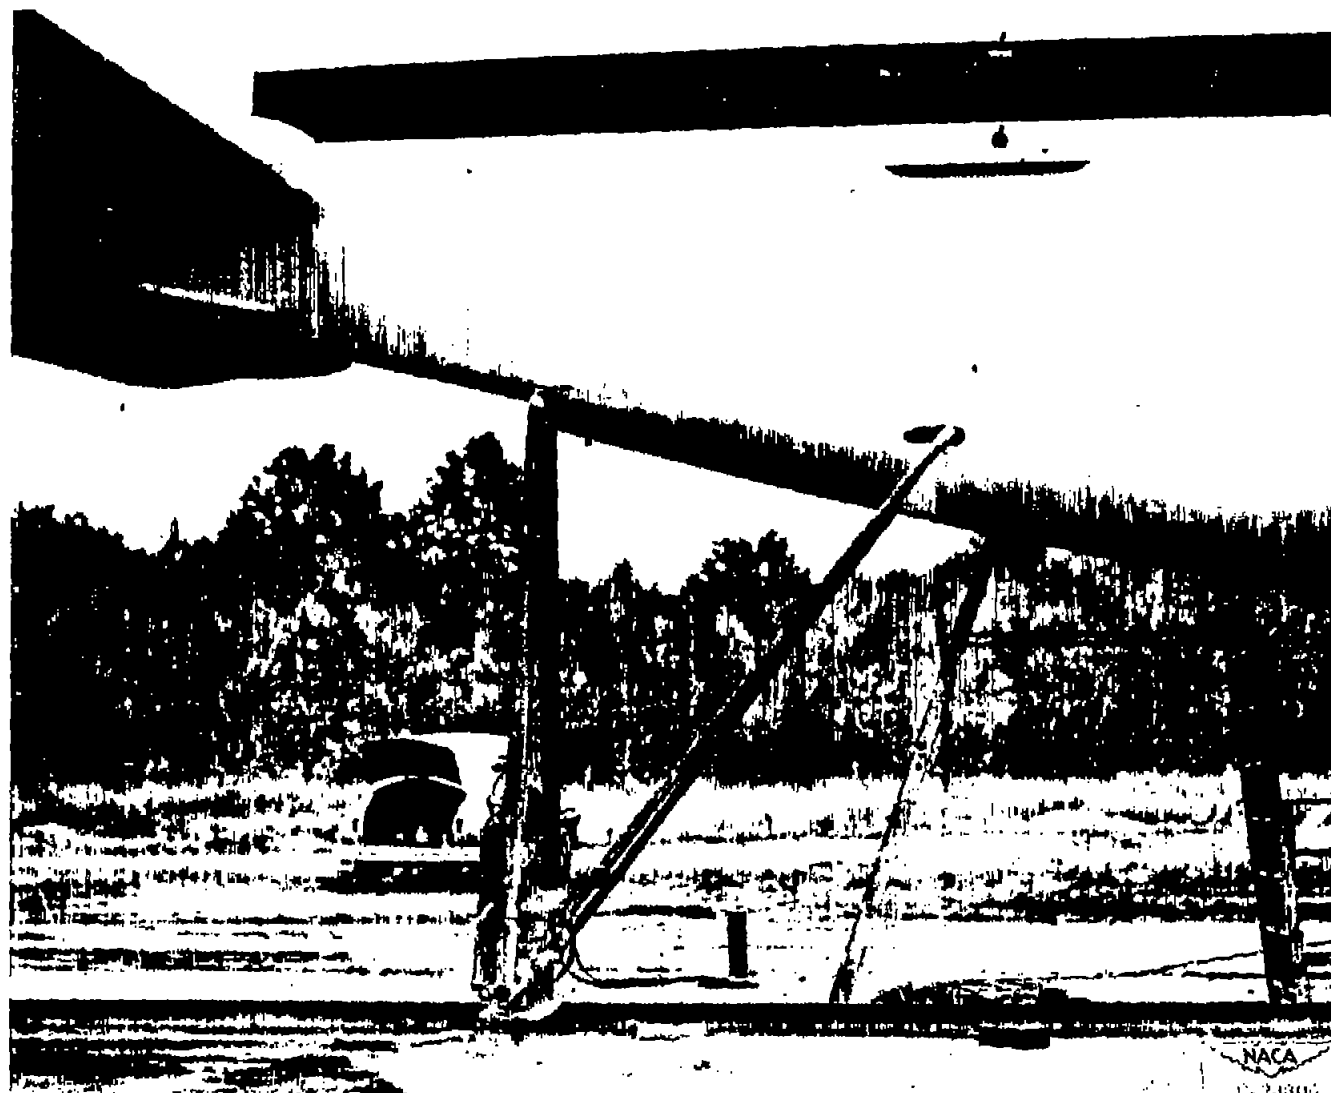
Figure 8. - Extended tail-truss support for holding C-46 airplane in flight attitude.

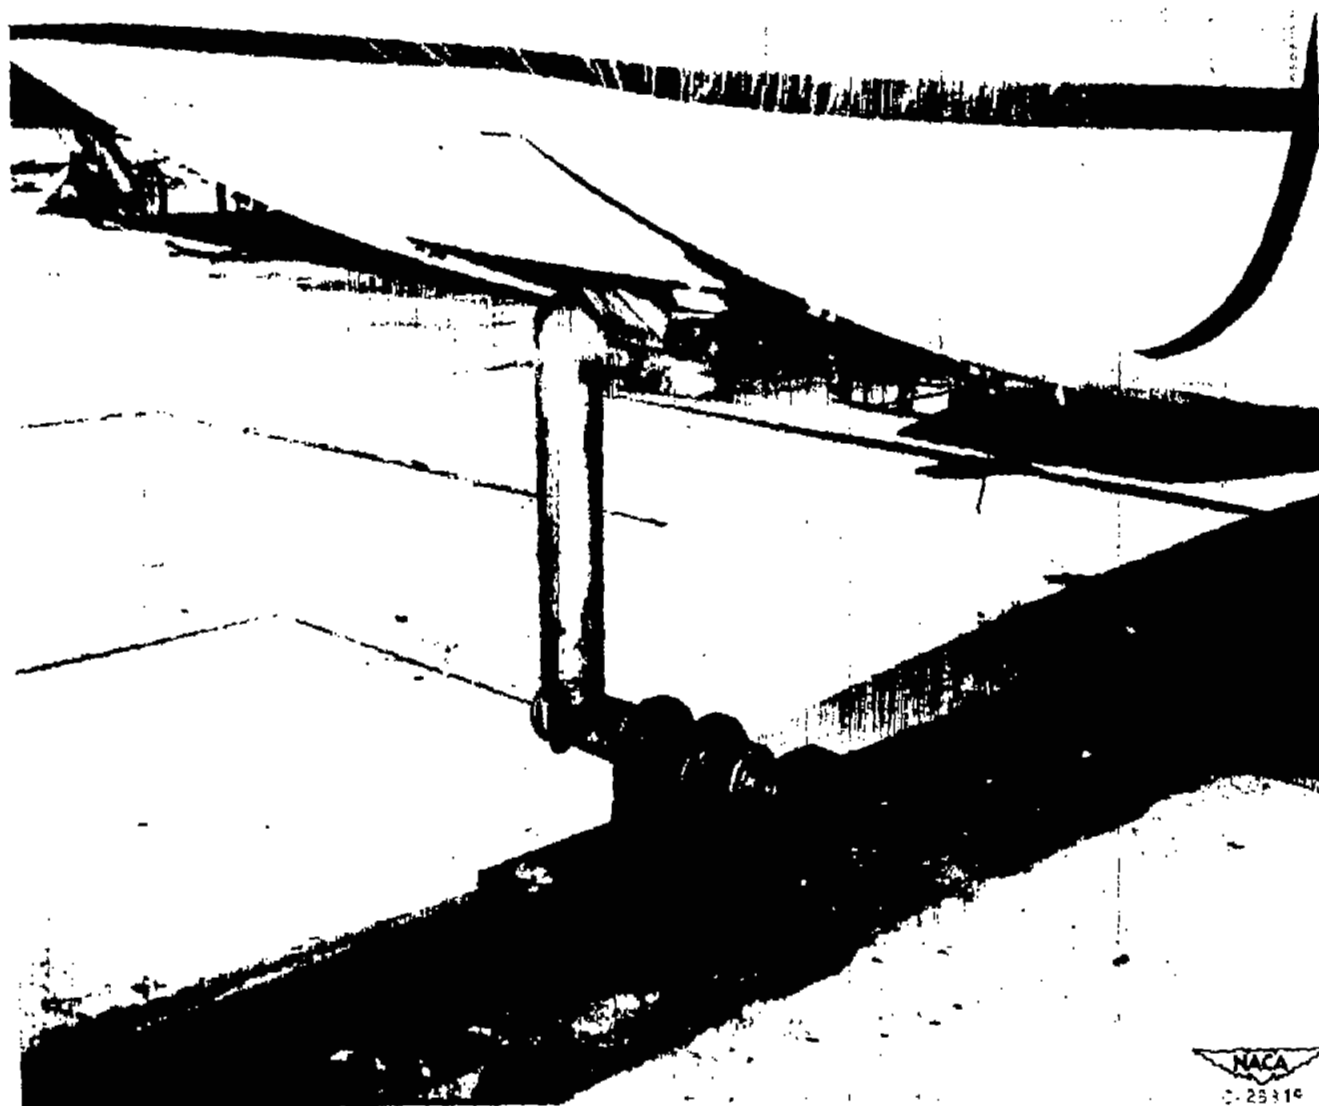
Figure 9. - Guide slipper attached to nose-gear axle of C-82 airplane.

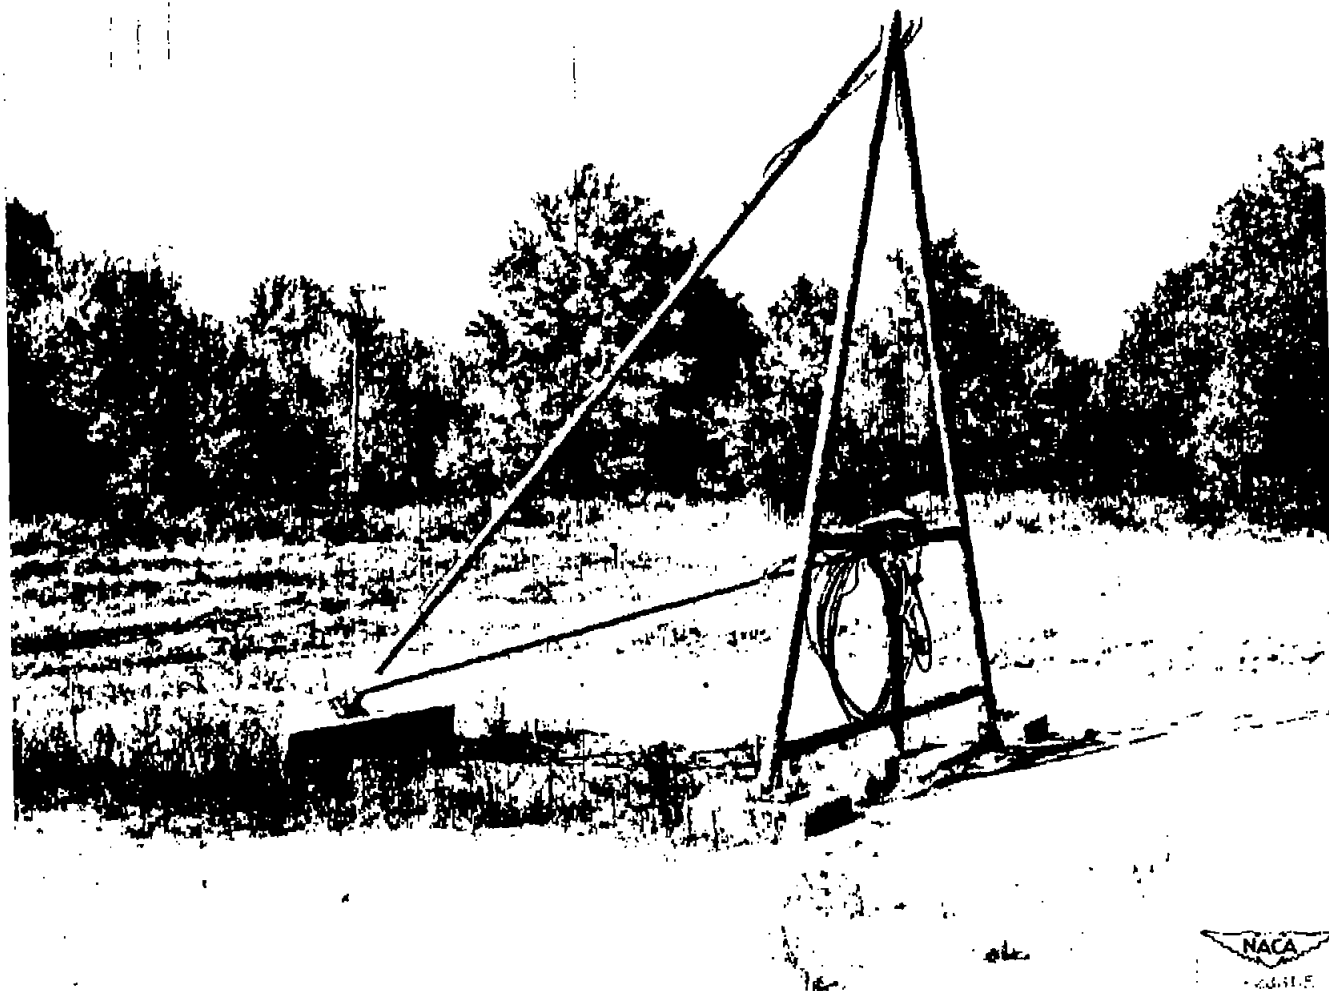
Figure 10. - Anchor pier for retaining airplane before release.

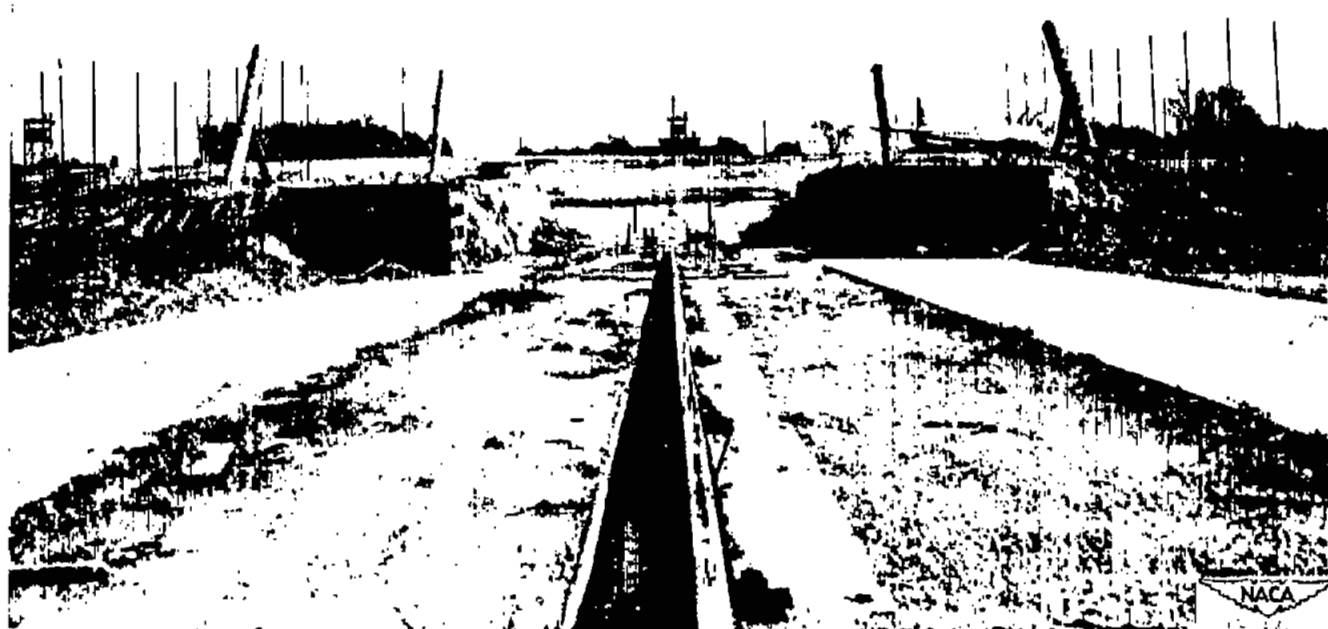
(a) For C-46 airplanes.

Figure 11. - Crash and pole barriers.

(b) For C-82 airplanes.

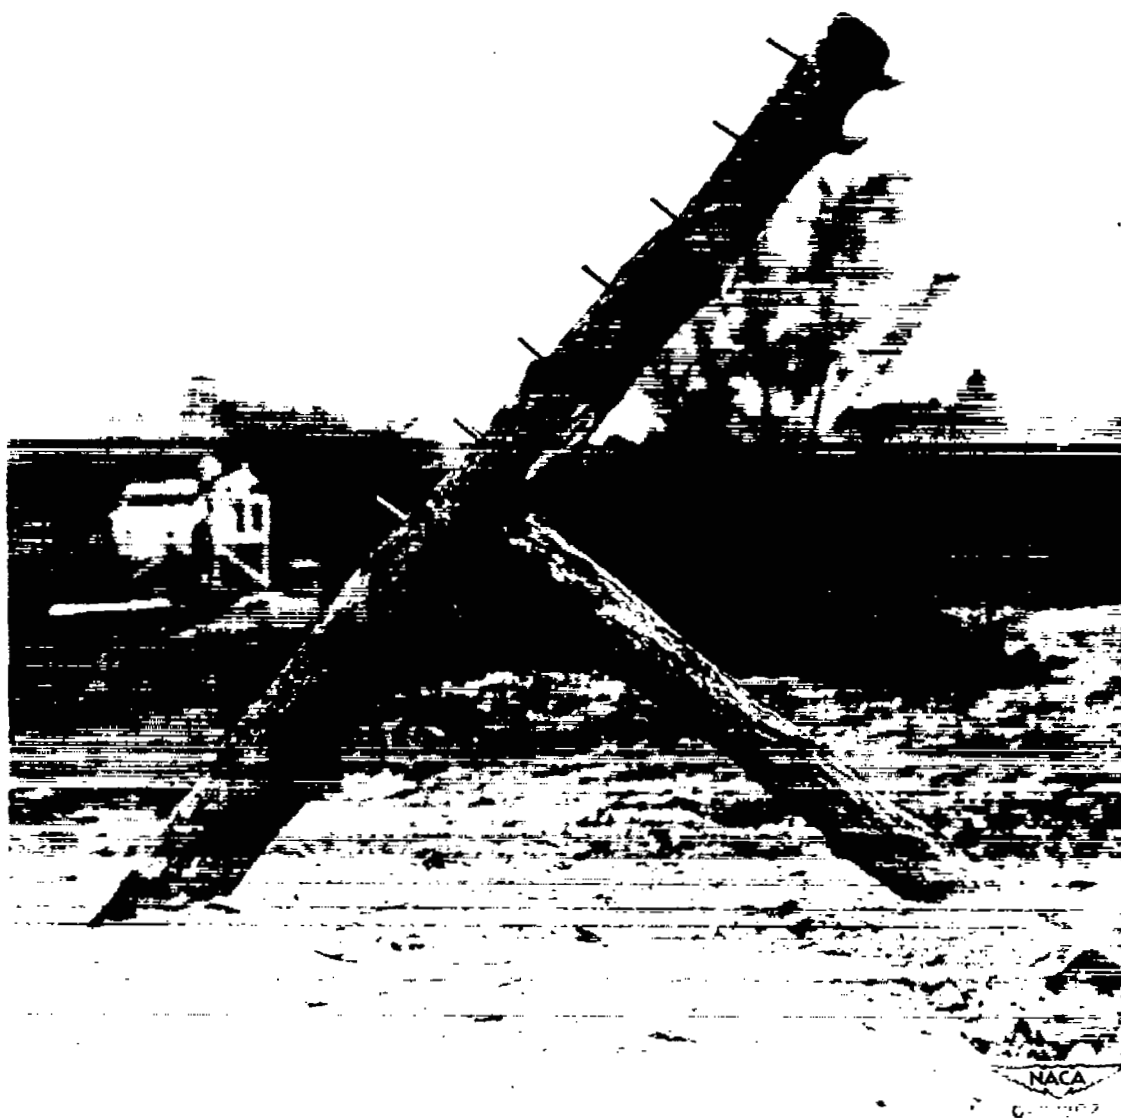
Figure 12. - Close-up of pole barrier showing steel spikes.

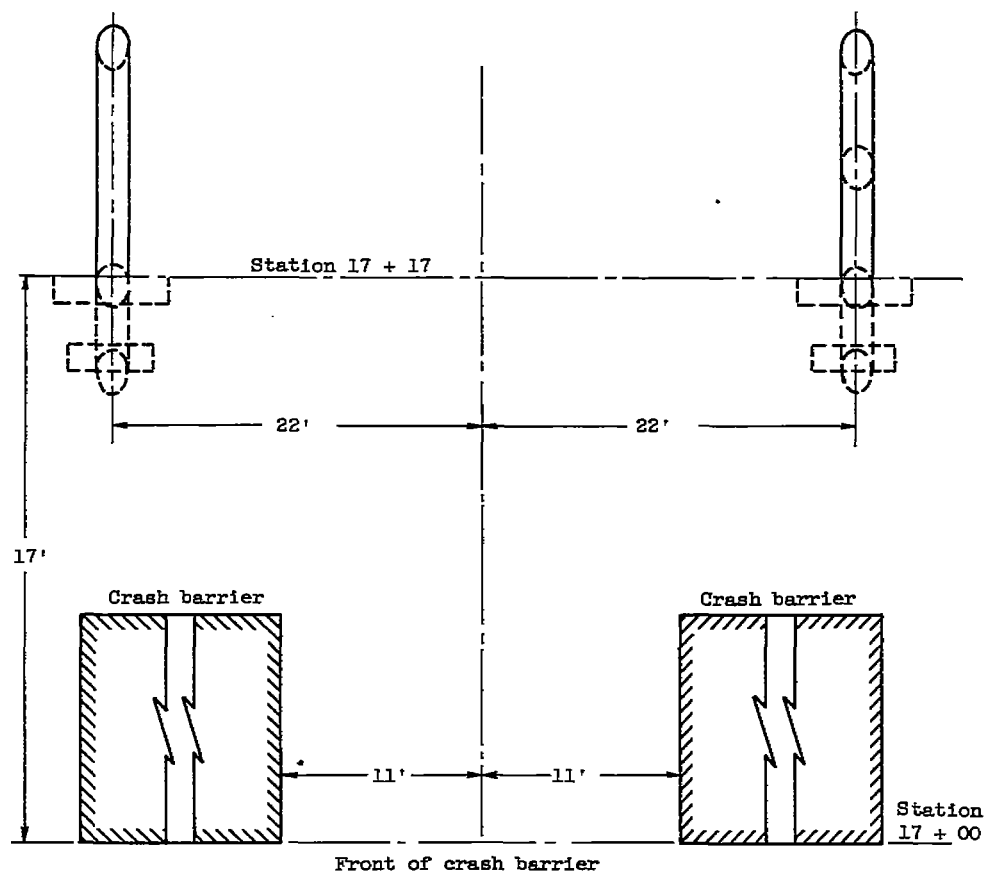
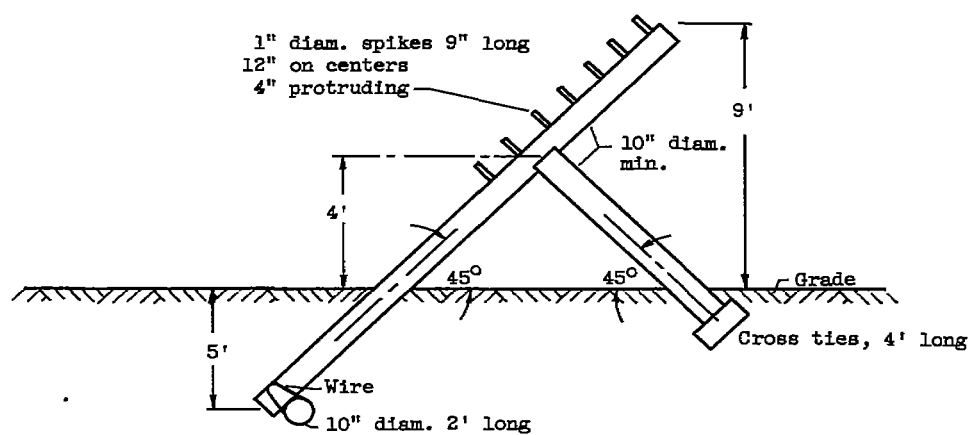
(a) Plan view of crash barrier.

(b) Side view of pole barrier.

Figure 13. - Sketch showing location of pole barrier for C-46 airplane crash tests.

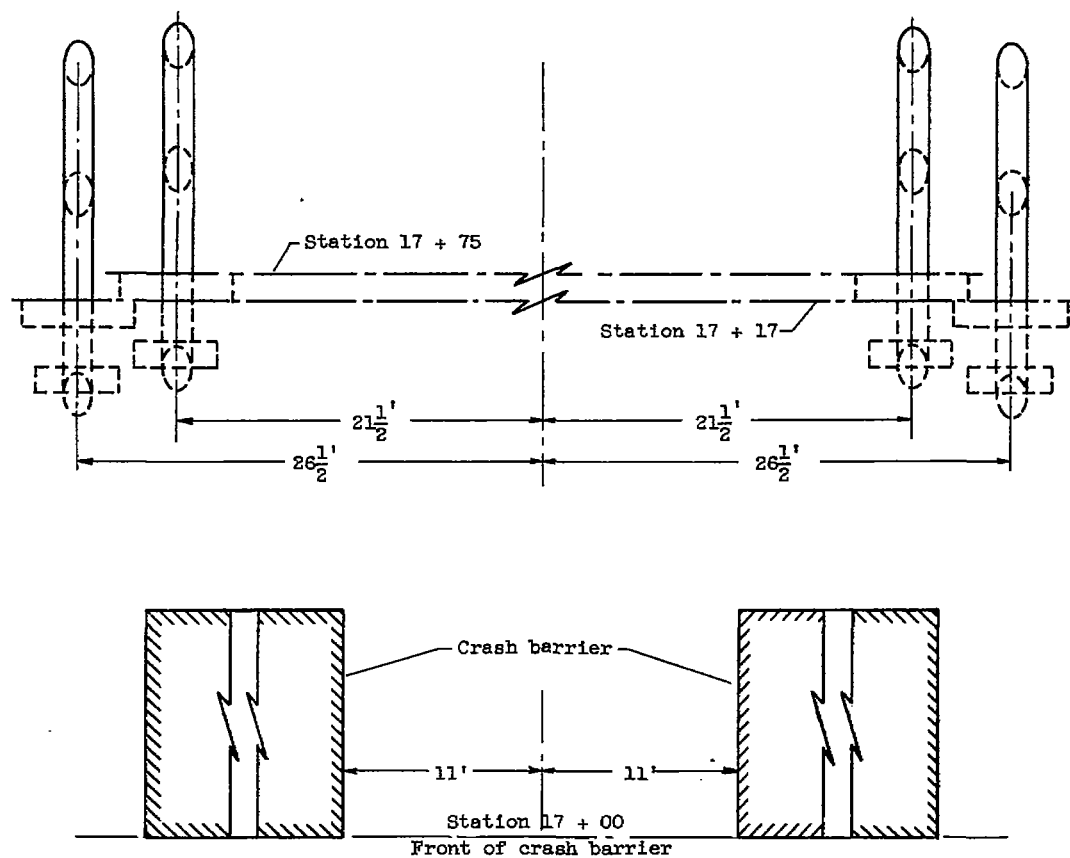
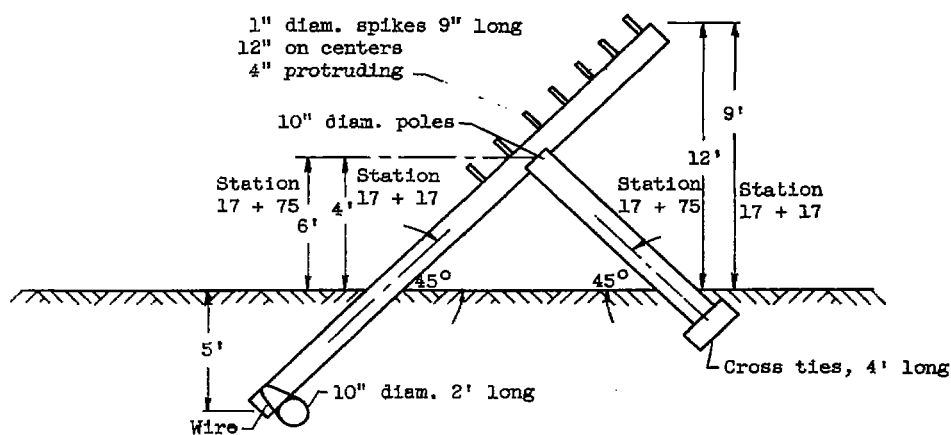
(a) Plan view of crash barrier.

(b) Side view of pole barrier.

Figure 14. - Sketch showing location of pole barrier for C-32 airplane crash tests.

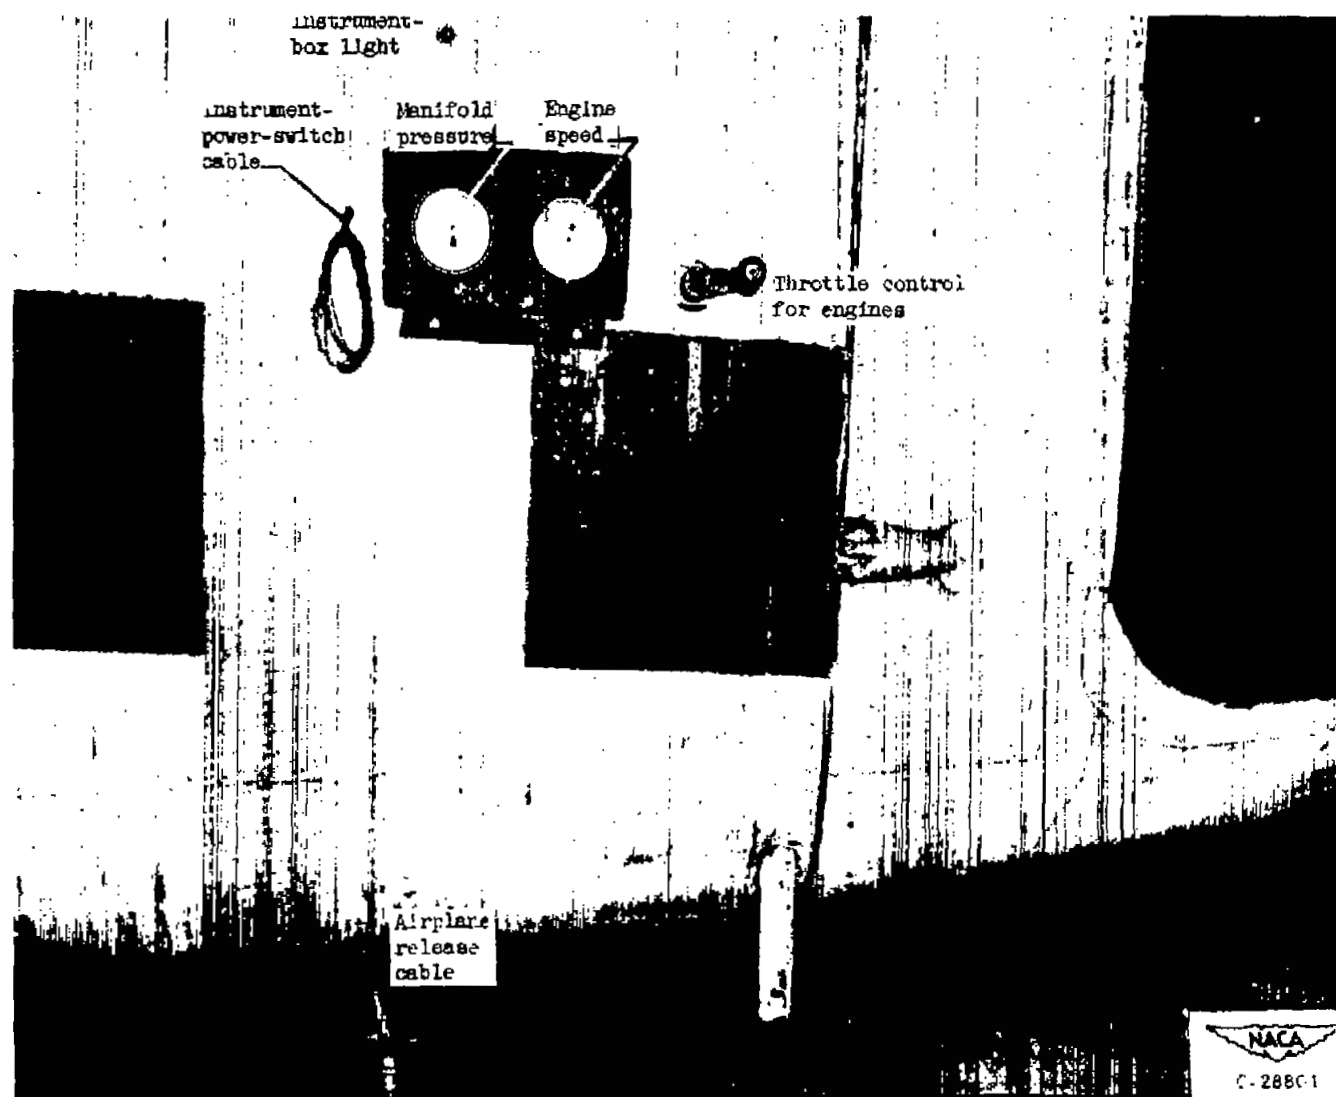
Figure 16. - Controls for operating engines, instrument box power, and airplane release located at rear of fuselage in C-82 airplane.

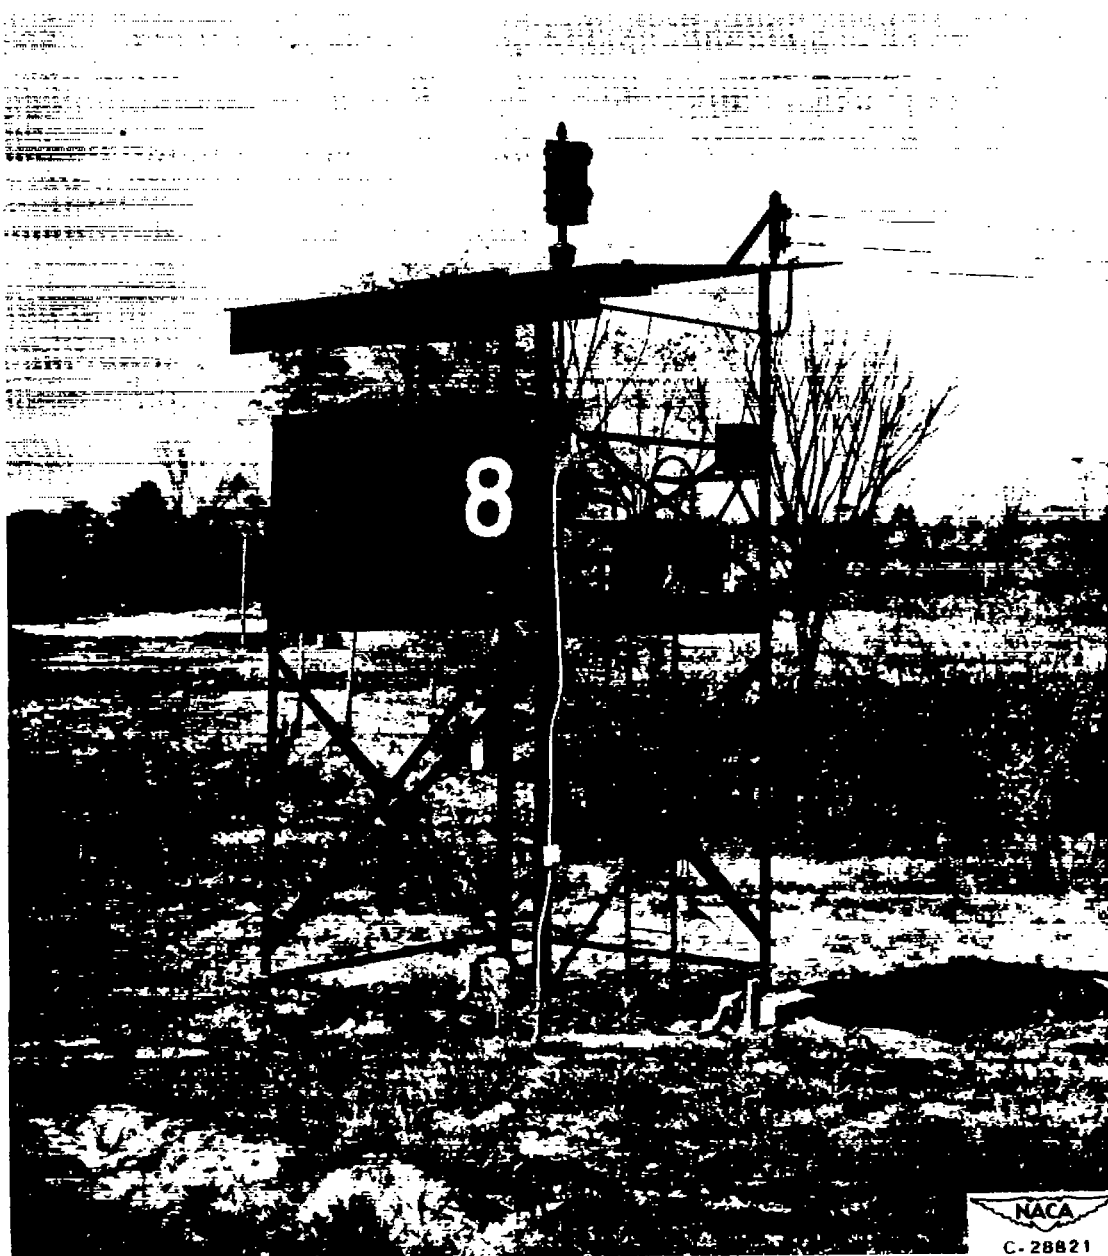
Figure 18. - Typical camera platform installation in crash area.

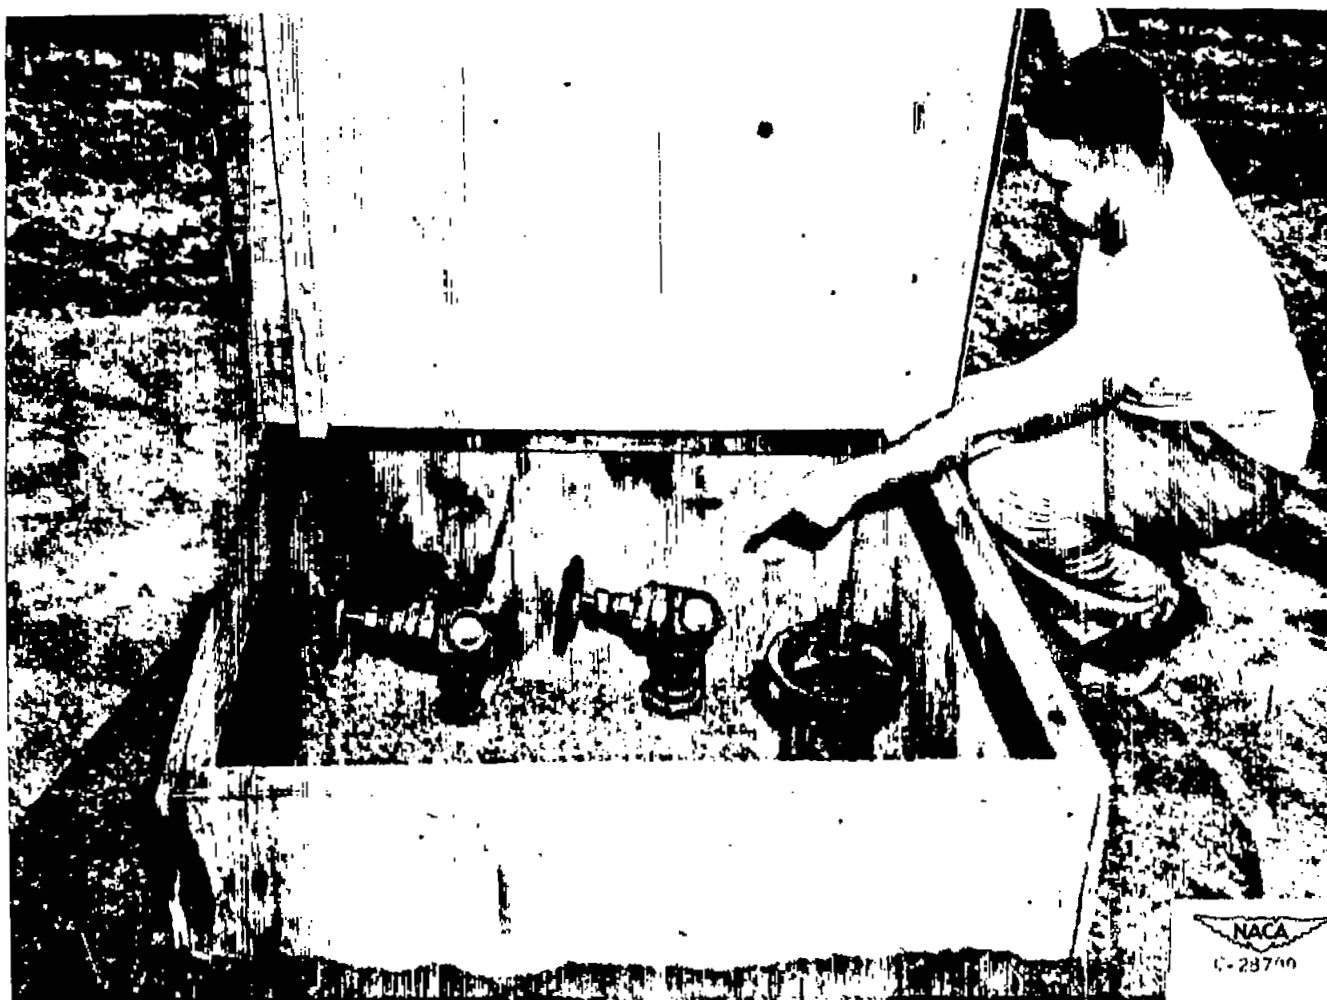
Figure 19. - Fire protection outlet located on each side of crash area.

A fire-protection system was constructed in the crash area to confine the fire to the crash zone. This system consisted of a water well, reservoir, pumper, underground lines, outlets, and ditches. A gasoline driven pump with a 500-gallon-per-minute capacity supplied water through underground pipes to two outlets located one on each side of the crash area as shown in figure 3. Two valves were contained in each outlet to which 300 feet of flexible hose was attached (fig. 19). A small ditch was excavated around the crash area to confine the spilled gasoline to the area.
